**Flood Control Project Maintenance
Levee Inspections**
LMA District Cover Sheet
Spring 2011 Levee Inspection Results

Reclamation District No. 0017 Mossdale

Levee Inspection Report By Mile - Spring 2011

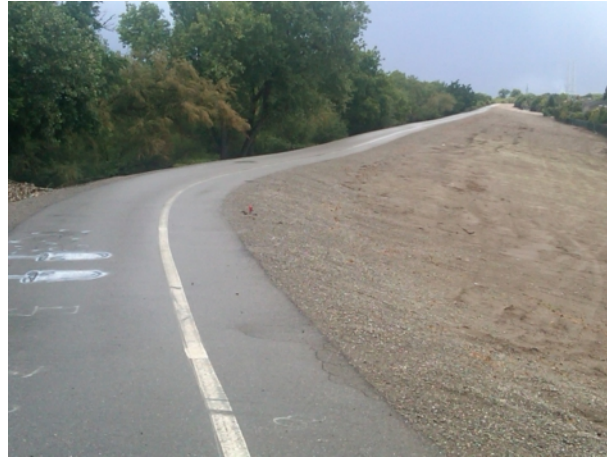
Levee Mile Report Line	2
Start Levee Mile	0.00
End Levee Mile	1.79
Location	Water Side
Category	Earthen Levee
Item	Vegetation
Looking upstream at typical view of levee.	
richard_s_20110602_558.jpg

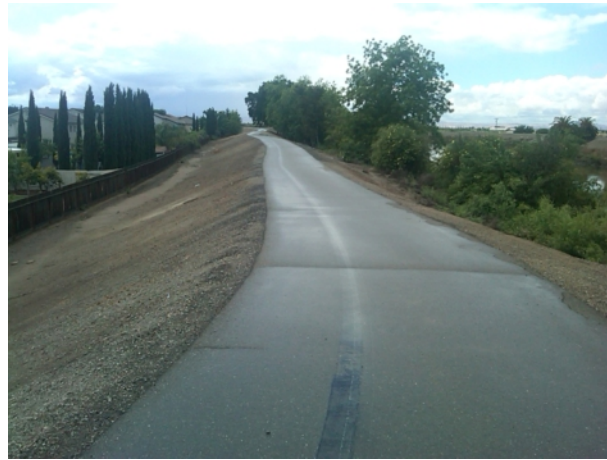
Levee Mile Report Line	2
Start Levee Mile	0.00
End Levee Mile	14.45
Location	Water Side
Category	Earthen Levee
Item	Vegetation

Looking downstream at typical view of levee.

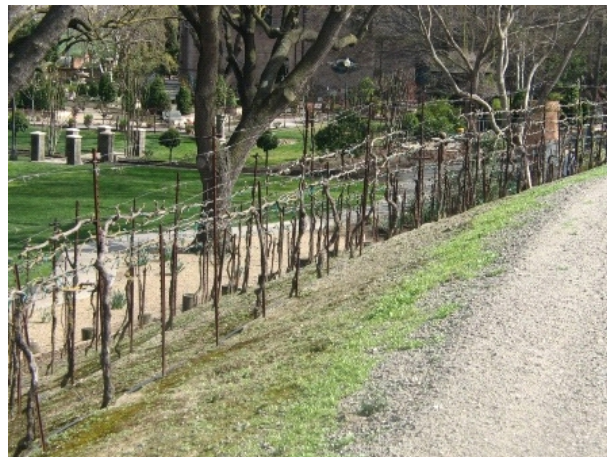
Levee Mile Report Line	7
Start Levee Mile	4.28
End Levee Mile	4.32
Location	Land Side
Category	Earthen Levee
Item	Encroachments

Grape vines on landside slope from LM 4.28 to 4.32

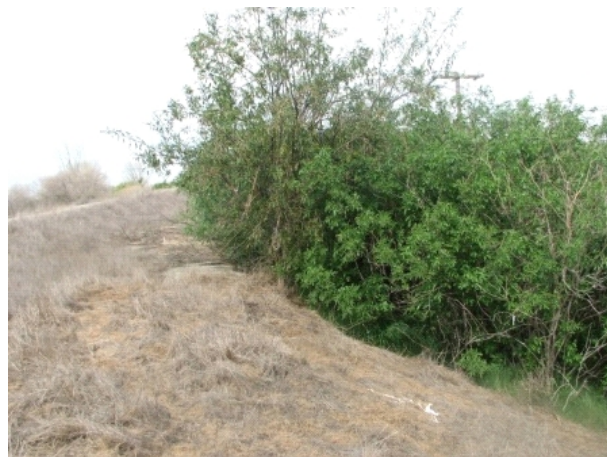
Levee Mile Report Line	15
Start Levee Mile	7.67
End Levee Mile	7.69
Location	Land Side
Category	Earthen Levee
Item	Vegetation

Elderberry blocking view of landside slope and toe from LM 7.67 to 7.69
